RE: Oak Trace (Project 16-056) Response to Request for Additional Information

# **Fairview 2009 Facility Assessment Report Update**

**October 27, 2009**

*Fairview*  
210 Village Drive  
Downers Grove, Illinois 60516

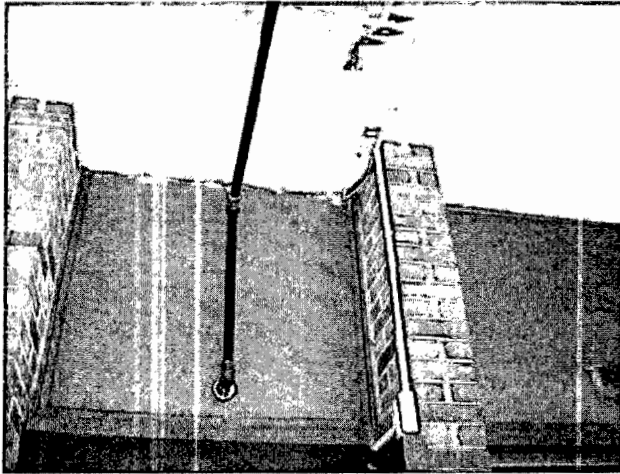
Exterior wall –  
Water issues at the green  
house. Insulated glass seal  
has be broken.

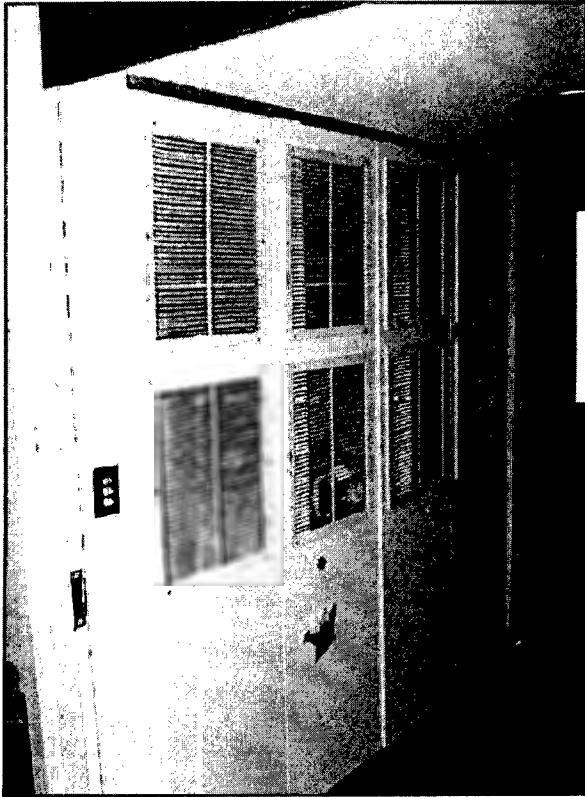
No sprinklers at the closet

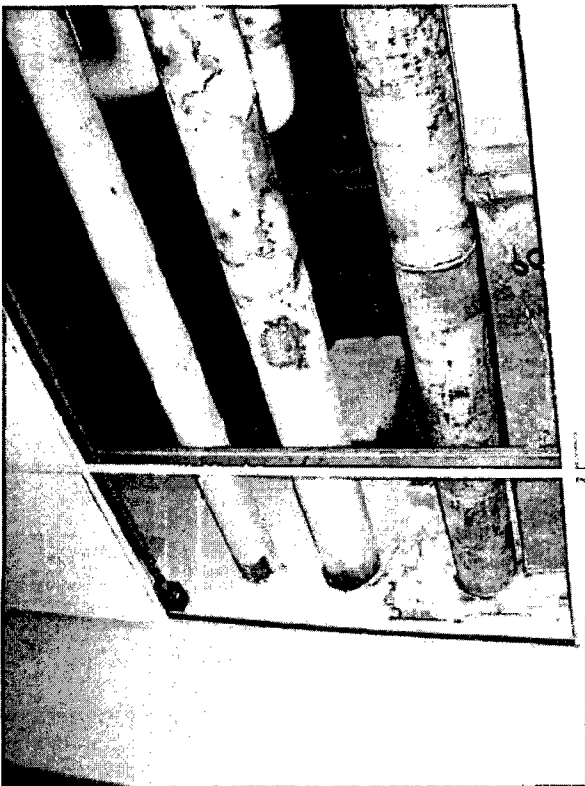
Water damaged insulation  
and corroded piping

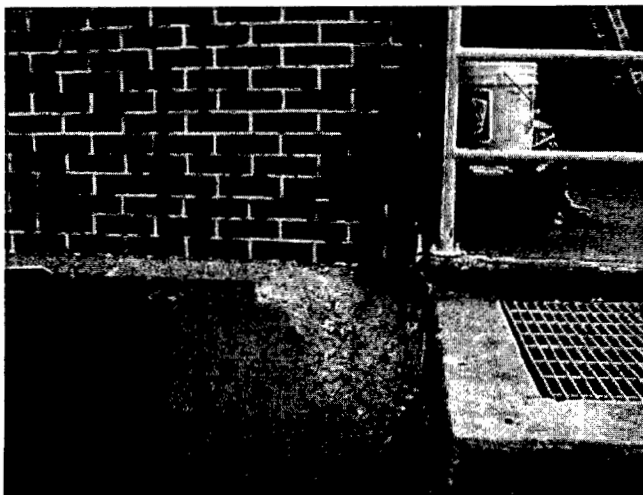
Exterior wall –  
Water entering Basement

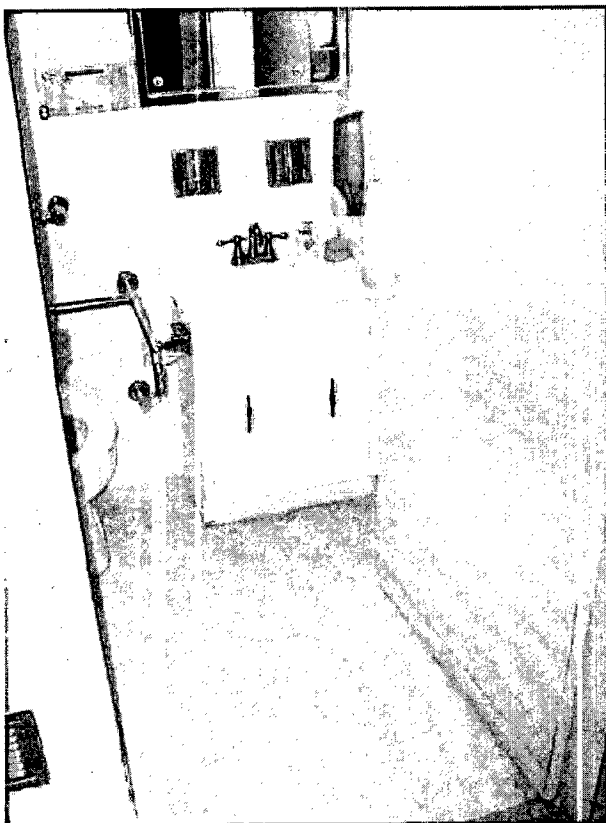
Typical resident toilet room  
requiring updating.

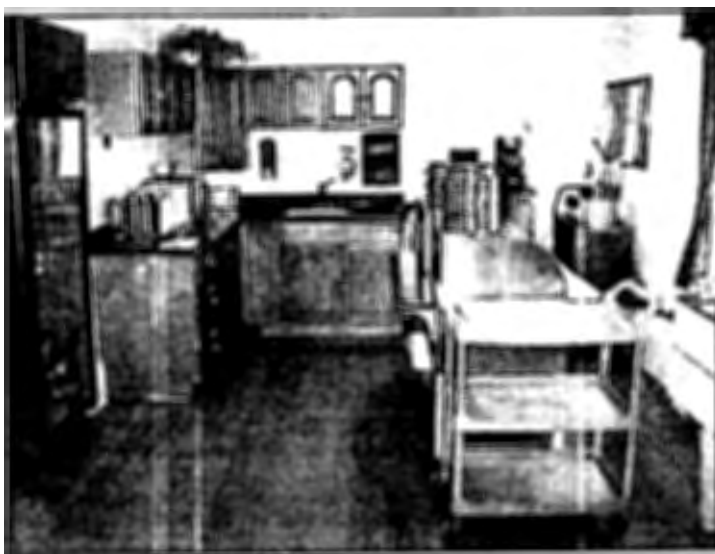
No ventilation in this area

Therapy Office \ Classroom has no ventilation at all. No systems are in place to provide the required ventilation in this area. This is a code violation that leads to increased chances of staff and resident health issues. Recommend that an air supply system be installed to provide code-required ventilation and have heating and cooling capabilities. Actual means and methods of installation will need to be determined. (1)

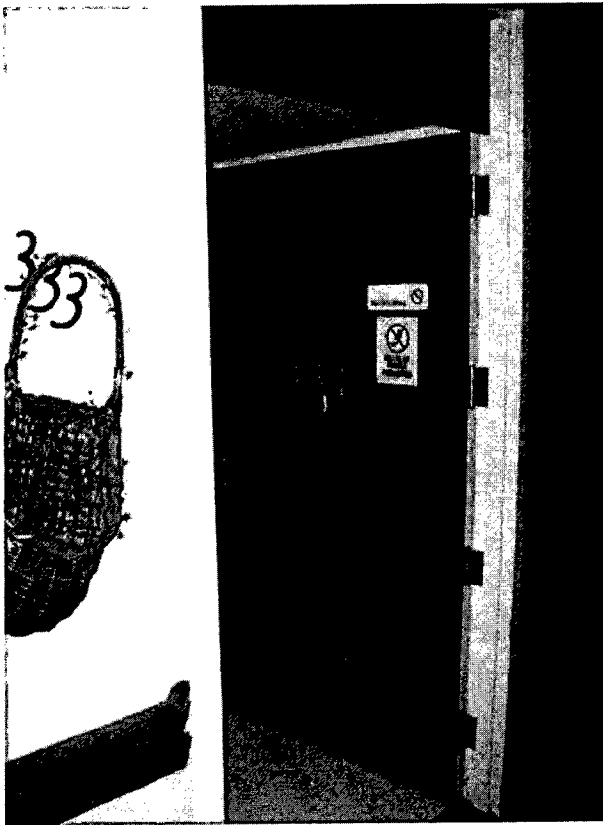
Typical resident room  
without closer and door is  
showing its age.

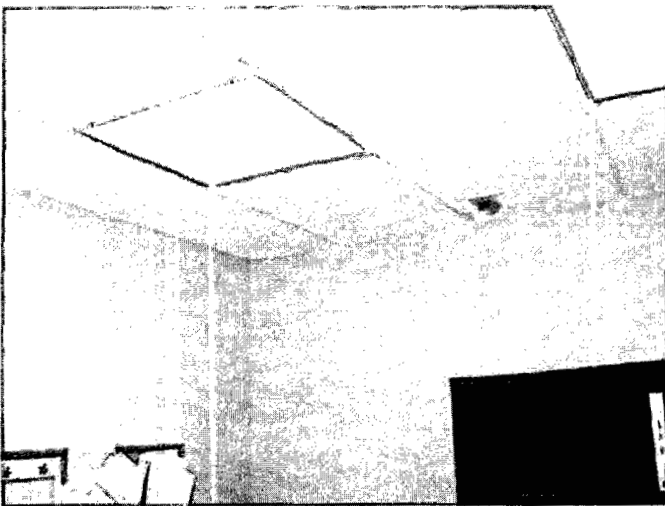
Water damage

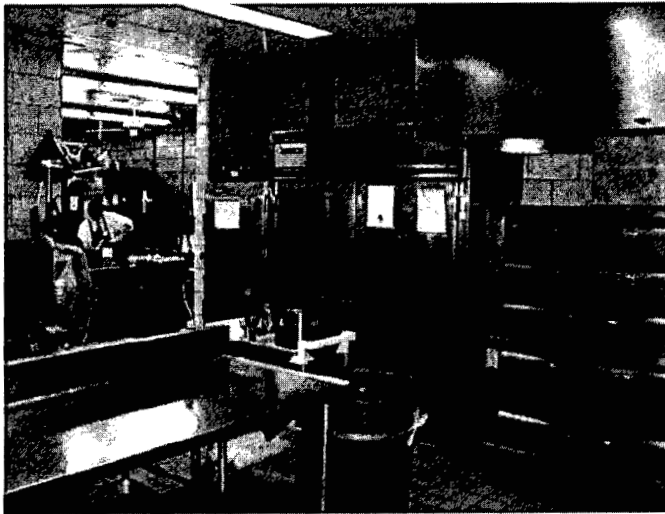
Aging food service  
equipment

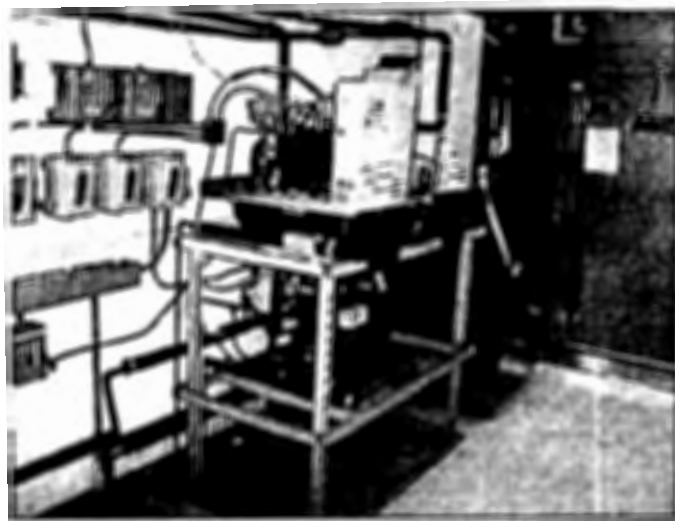
Water cooled Condensing  
units.

- Investigate natural gas drop in pressure issue.
- Replace varies mechanical equipment, such as aged pumps. Etc...
- Provide ventilation at indoor condensing units. Convert water cooled condensers.

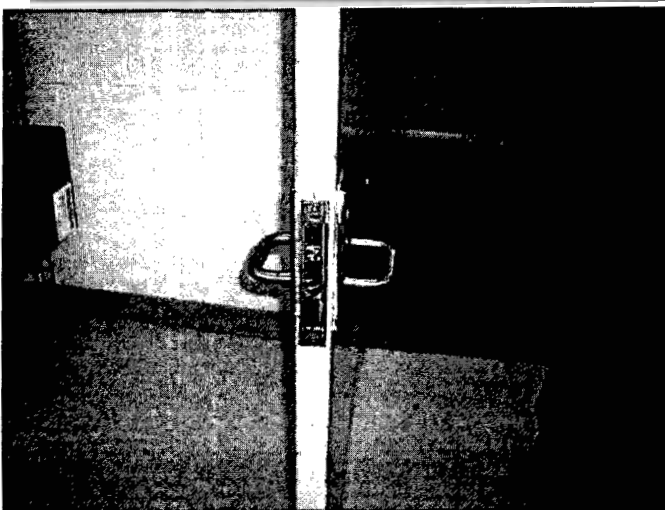
Damaged Hardware
